STAFF REPORT TO THE COMMISSION

ComEd Smart Meter Fires

August 28, 2013

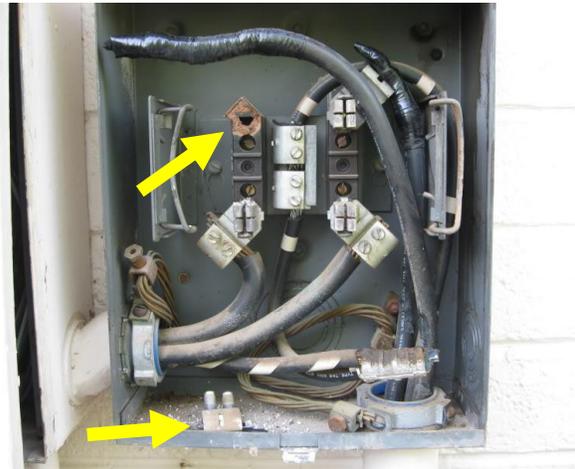
Generic Internet Photo of Meter Base With Damaged Top Left Connection Jaw That Is Now Broken Loose and Laying On the Bottom of the Meter Base

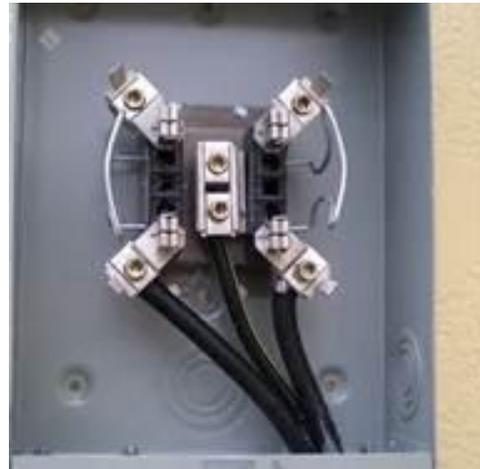
Generic Internet Photo of Meter Base With All Connectors in Like New Condition
